THE QUITO, ECUADOR, EARTHQUAKE RISK MANAGEMENT PROJECT

AN OVERVIEW

Escuela Politécnica Nacional; GeoHazards International; Ilustre Municipio de Quito; ORSTOM, Quito; and OYO Corporation, *The Quito, Ecuador, Earthquake Risk Management Project: An Overview*. (San Francisco: GeoHazards International, 1994.)

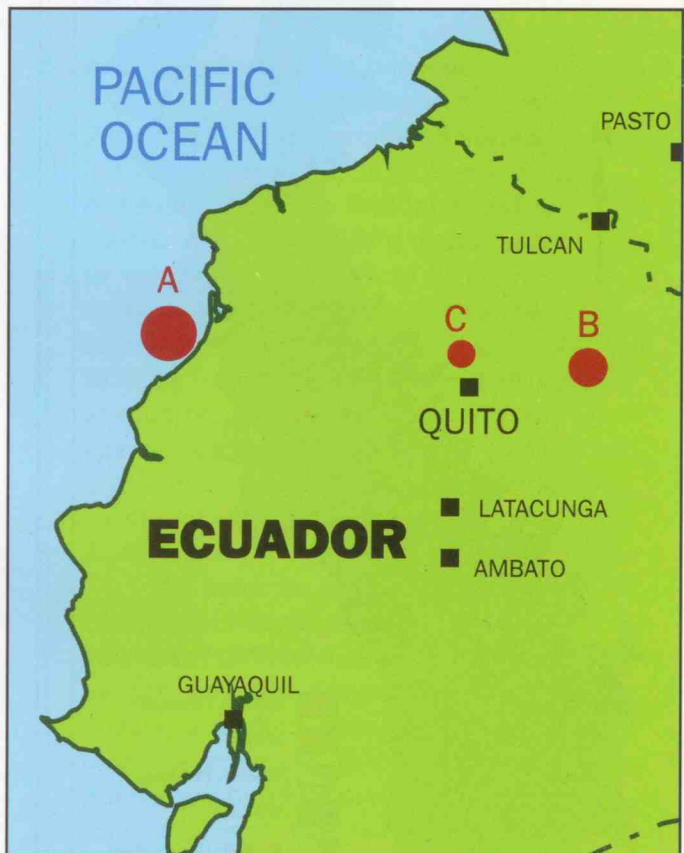
Figure 3. Location of the potential coastal (A), inland (B), and local (C) earthquakes with respect to Quito.

Geologists and seismologists attempted to determine the magnitude and location of earthquakes that would likely damage Quito in the future. They analyzed Ecuador's faults and earthquake records dating back to the 16th century. Three earthquakes, representing the range of possible magnitudes and distances, were selected for detailed assessment (Figure 3):

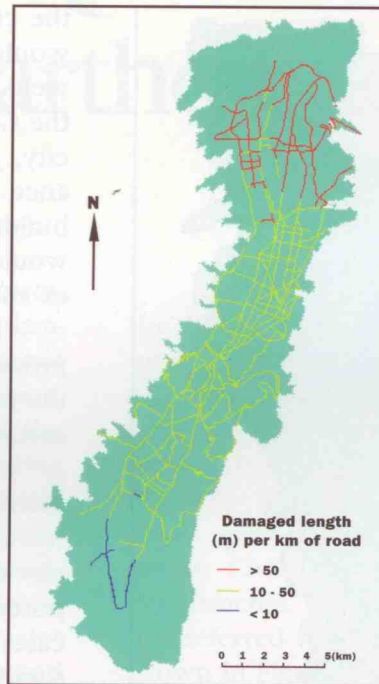
Figure 9. Damage to roads resulting from the potential local earthquake.

Damage to the roads, water system, power network, and sewers resulting from the potential local earthquake will likely be severe as well (Figures 9, 10, 11, and 12).

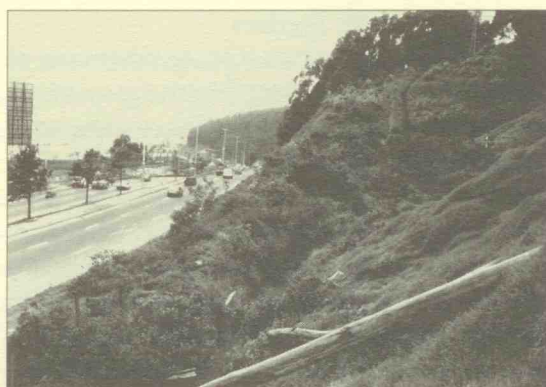
Slopes susceptible to landslides along Via Occidental.

Landslides block Via Oriental and Via Occidental, especially in lanes next to cut slopes. Northern access to the city is interrupted by landslides on Panamericana Norte, the road to the Mitad del Mundo, and the road through Calacali to the coast. Several large landslides and rocks fall on the Tabacundo Highway and Via Interoceanica, making them impassable. A bridge on the Panamericana Norte is heavily damaged, rendering it, too, unusable. Several secondary streets in northern Quito suffer cracking. Northwestern neighborhoods such as Jaime Roldos, Pisuli, and Comite del Pueblo 2 become isolated. Some roads in the northeast are partially blocked; slope failure at the Zambiza garbage dump cuts the only access to that area. Several main north-south avenues are blocked by damaged overpasses. Some motorists, unable to proceed, abandon their cars in the middle of the street. More than a hundred obstructions in the roads of Quito make transit within the city and between northern, central, and southern Quito almost impossible.
